Site Accessibility Evaluation

Americans with Disabilities Act And Title 24 And Part 2 - California Building Code

**Work Net Office Building
Suites 102-133**

**543 W Grant Line Rd
Tracy, CA 95376**

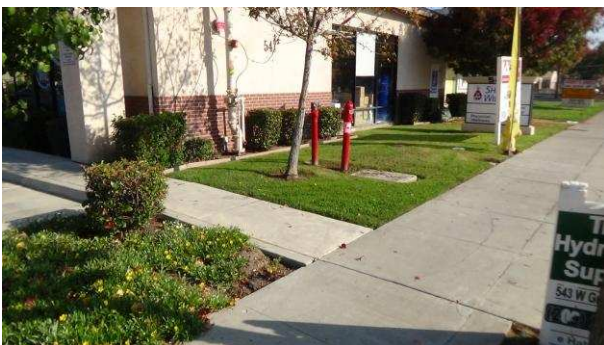
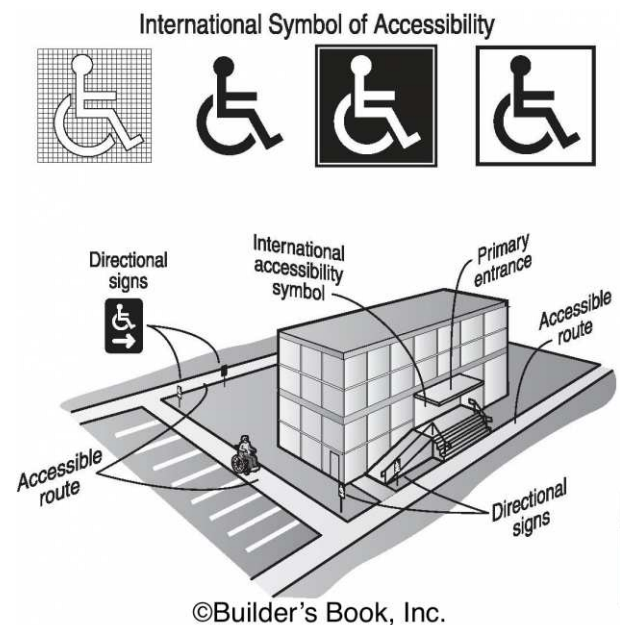
Finding: 1

The walk is missing directional signage that identifies the location/direction of the accessible route of travel to the accessible building entrance.

None

Install directional sign.

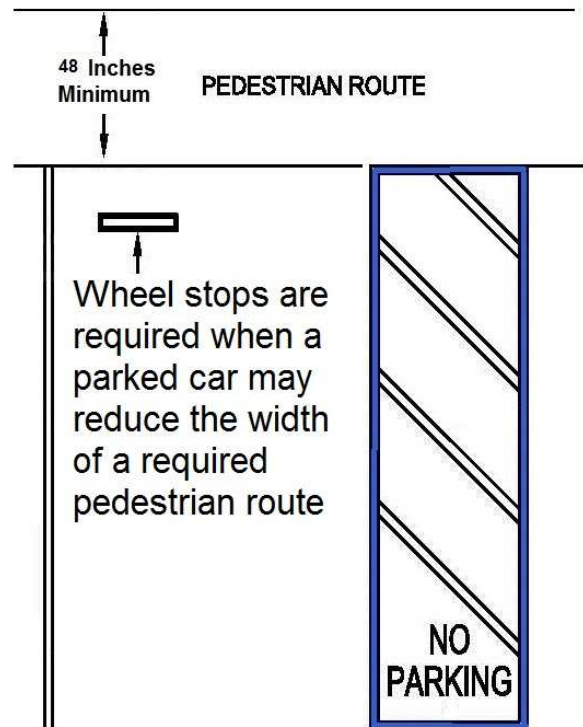
Finding: 4

Parked vehicles shall not reduce the required width of the accessible route.

<48"

Install wheel stops at all parking stalls along the path of travel (walk).

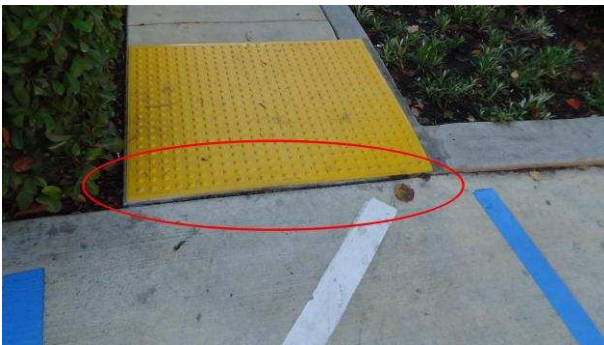
Finding: 7

The walkway contains abrupt vertical edges and/or variations over a 1/4 inch.

3/4" - 1"

Smooth out abrupt-edge transition to within a 1/4". Edge treatment recommended.

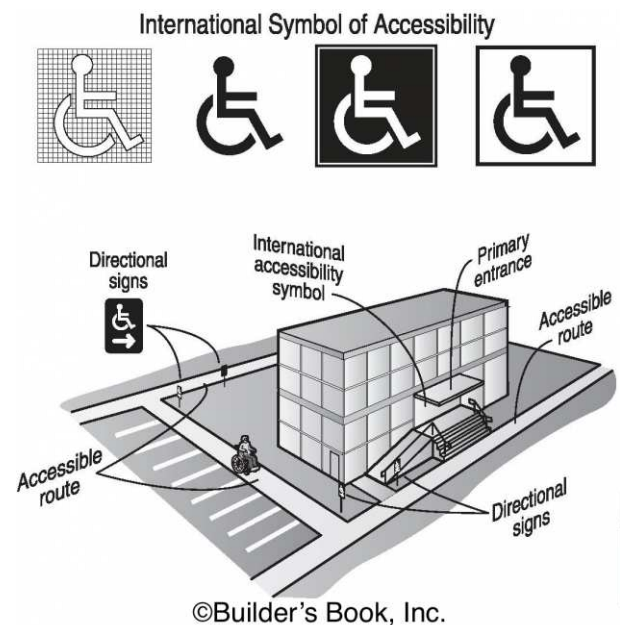
Finding: 8

The walk is missing directional signage that identifies the location/direction of the accessible route of travel to the accessible building entrance.

None

Install directional sign.

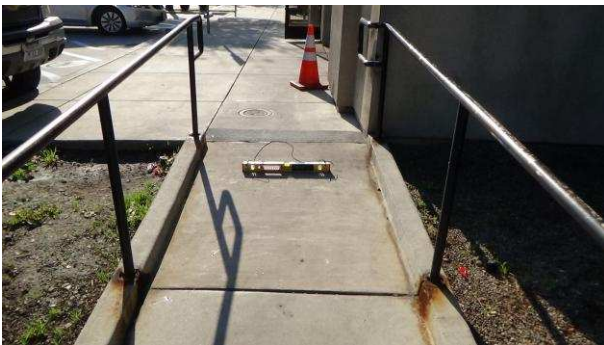
Finding: 9

The ramp on the accessible route contains cross slopes greater than 2%.

2016 CBC 11B Section: 11B-405.3	2.6% - 3.1% (1 panel)	\$1500.00 - \$6500.00
---------------------------------	-----------------------	-----------------------

Remove and replace all non-complaint concrete panels. Services of a Licensed Architect, Registered Engineer or Licensed Contractor may be required.

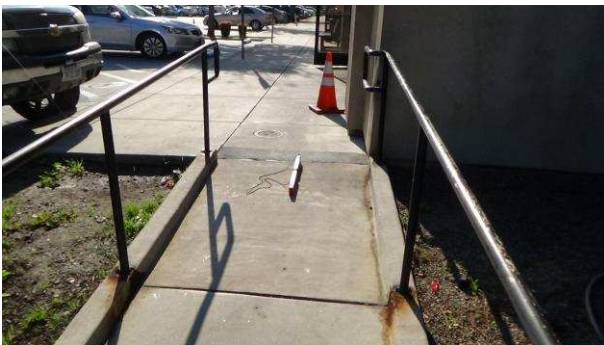
Finding: 10

The ramps slope exceeds the maximum running slope (direction of travel) allowable of 8.33%.

2016 CBC 11B Section: 11B-405.2	8.8% - 9.6% (1 panel)	\$1500.00 - \$6500.00
---------------------------------	-----------------------	-----------------------

Remove and replace all non-complaint concrete panels. Services of a Licensed Architect, Registered Engineer or Licensed Contractor may be required.

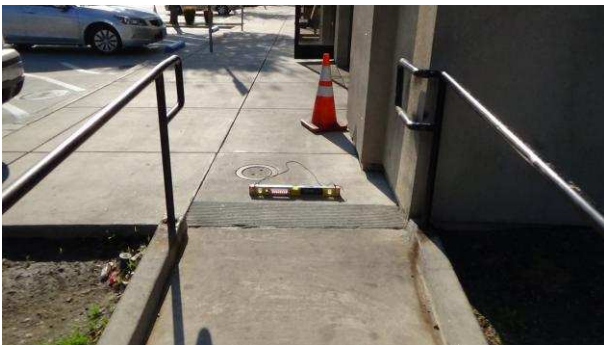
Finding: 11

The landing at the top of the ramp has a slope greater than 2%.

2.6% (1 panel)

Remove and replace all non-complaint concrete panels. Services of a Licensed Architect, Registered Engineer or Licensed Contractor may be required.

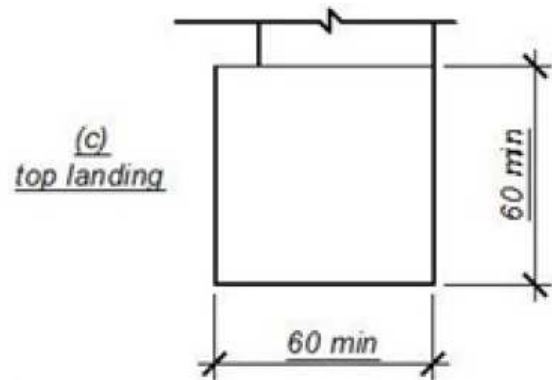
Finding: 12

The top landing of the ramp is not the correct size.

<60" at 7" wall "jog"

Widen top panel of ramp to accommodate wall jog. Services of a Licensed Architect, Registered Engineer or Licensed Contractor may be required.

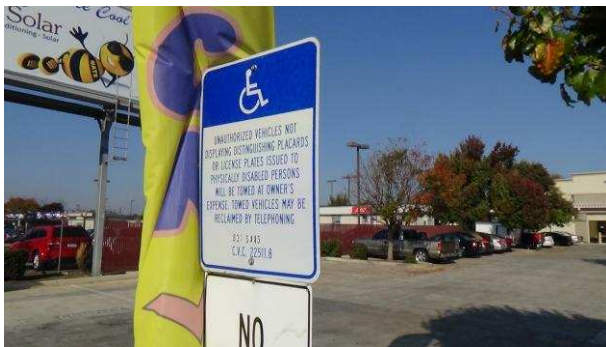
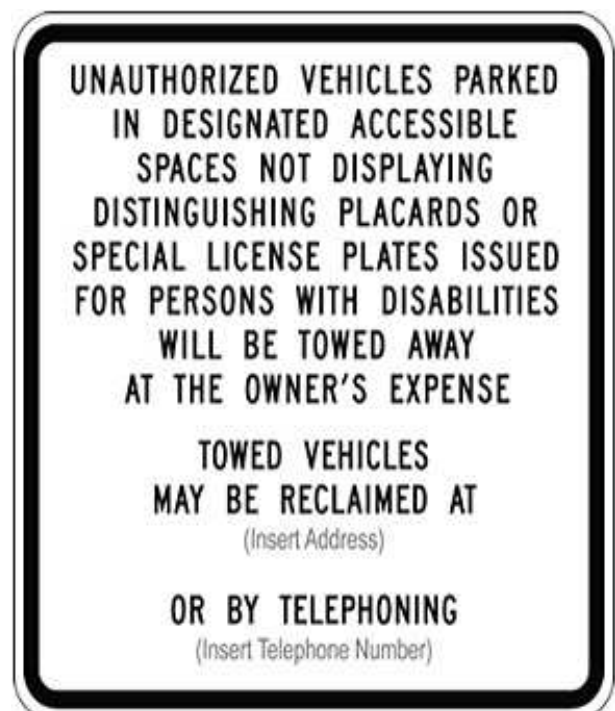
Finding: 13

The tow-away sign is incorrectly worded. Look for the words "Special" and "Will".

Outdated sign

Replace sign.

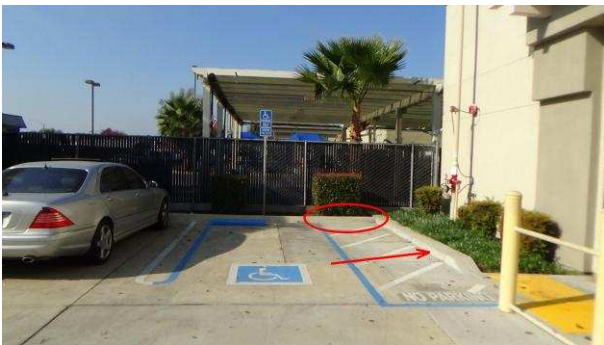
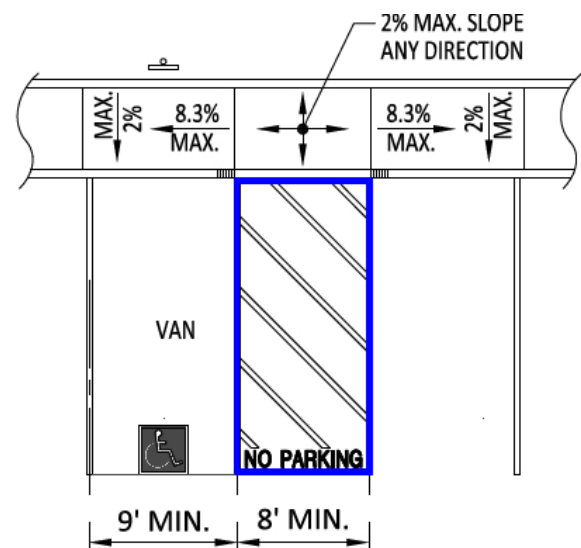
Missing on all edges

Install blue border around all edges of the access aisle.

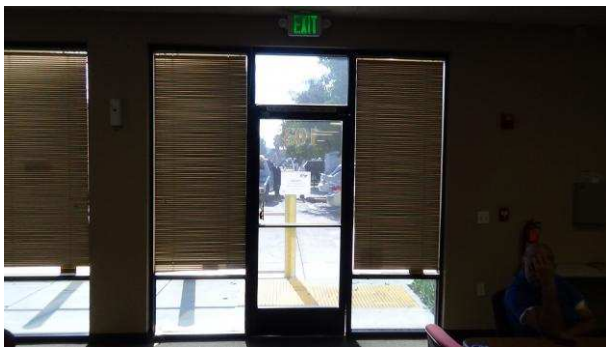
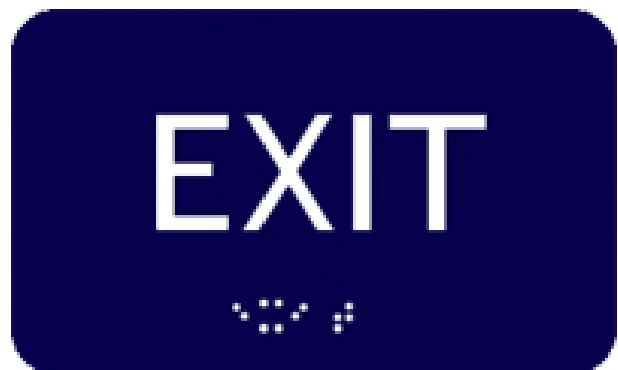
A tactile EXIT sign is missing at each entrance door.

Install tactile exit sign adjacent to each door as specified.

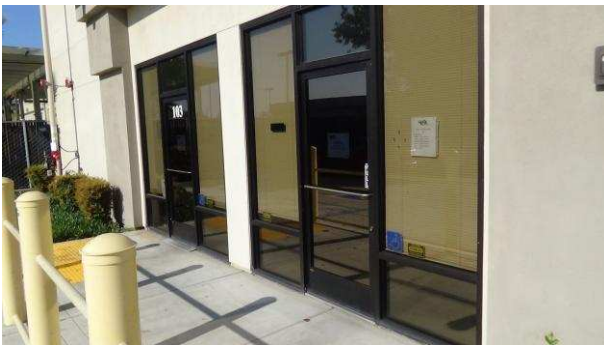
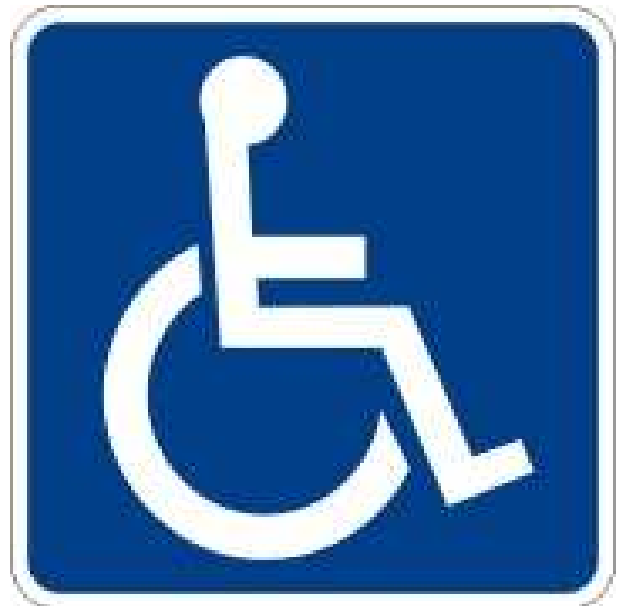
The ISA symbol at each entrance is faded/worn and in need of replacement and or repair.

Replace ISA stickers with a new ones.

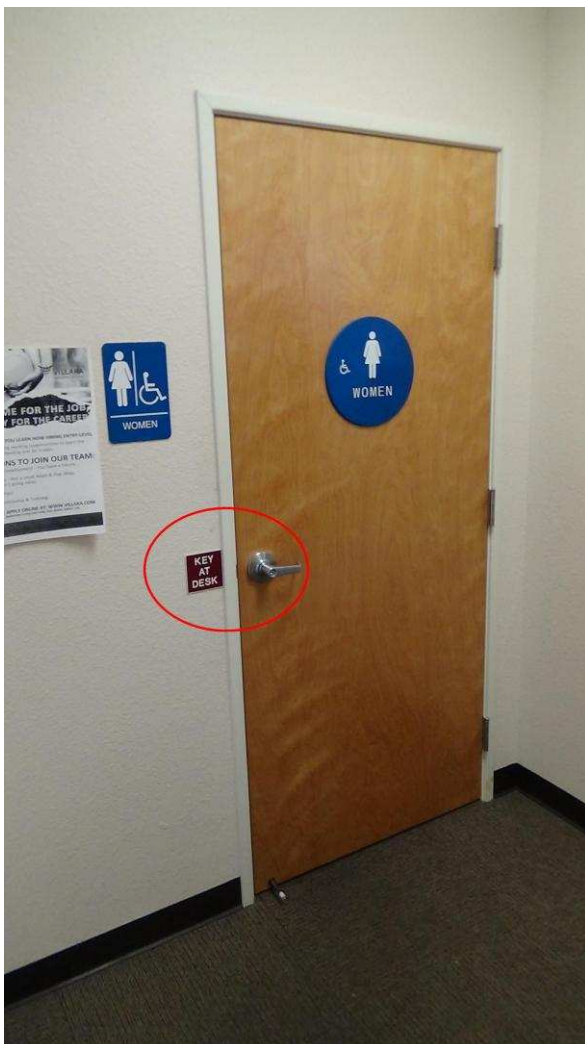
Finding: 44

Operating hardware must be centered between 34" and 44" above the floor or ground

Recommend installing a staff activated deactivation lock for all customers using the restroom or consider a The Norco™ Key Turner III. More info here: https://www.ncmedical.com/item_180.html

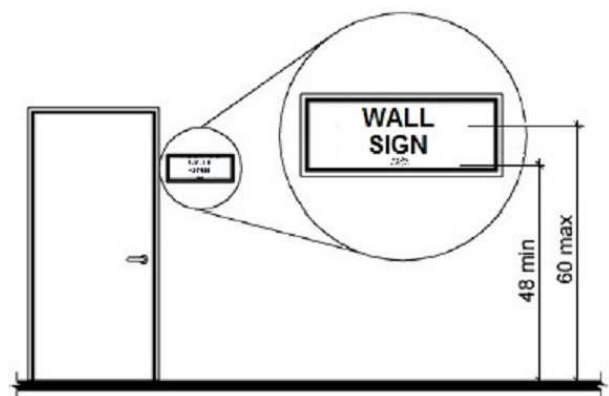
Compliant room identification signs are missing on the strike side of the door.

Missing Tactile "Data Room: wall sign

Add compliant tactile and braille wall sign for "Data Room" as specified or remove "Data Room" sign from the door.

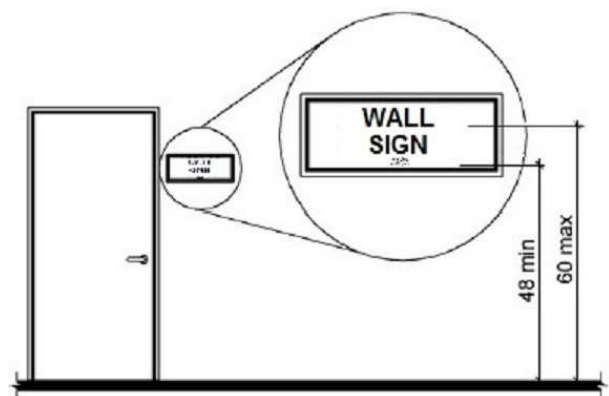
Compliant room identification signs are missing on the strike side of the door.

Missing Tactile
"Storage Room: wall
sign

Add compliant tactile and braille wall sign for "Storage Room" as specified or remove "Storage Room" sign from the door.

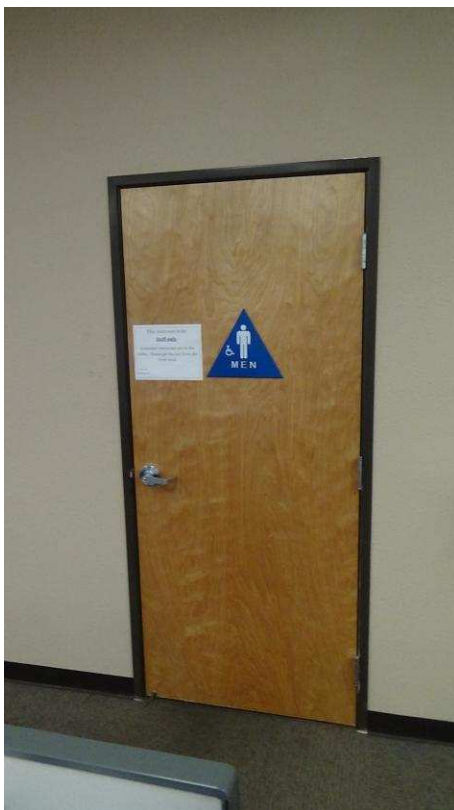
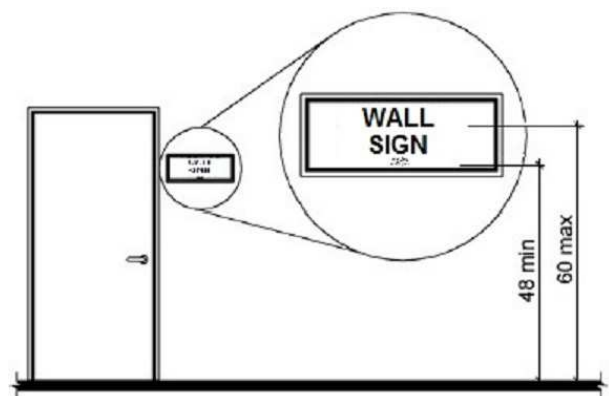
Finding: 55

Compliant room identification signs are missing on the strike side of the door.

Missing Tactile "Staff
Only: wall sign

Add compliant tactile and braille wall sign for "Staff Only" as specified or remove "Staff Only" paper sign from the door.

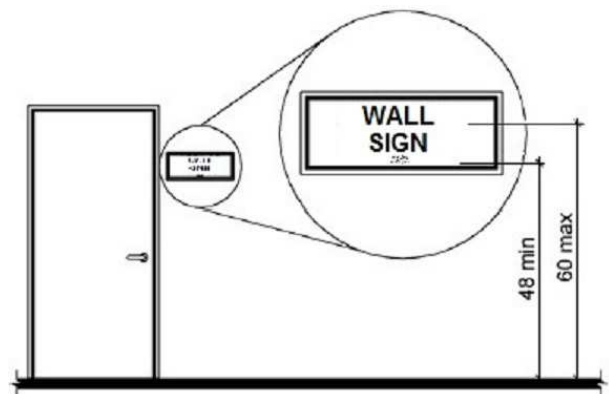
Compliant room identification signs are missing on the strike side of the door.

Missing Tactile "Staff
Only: wall sign

Add compliant tactile and braille wall sign for "Staff Only" as specified or remove "Staff Only" paper sign from the door.
