Site Accessibility Evaluation

Americans with Disabilities Act And Title 24 And Part 2 - California Building Code

**Work Net Office Building
Suites 102-133**

**543 W Grant Line Rd
Tracy, CA 95376**

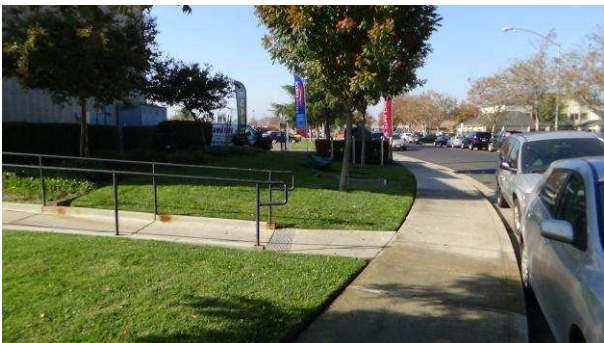
Finding: 9

The ramp on the accessible route contains cross slopes greater than 2%.

Surface cross slopes shall not exceed one unit vertical in 48 units horizontal (2-percent slope).

Remove and replace all non-complaint concrete panels. Services of a Licensed Architect, Registered Engineer or Licensed Contractor may be required.

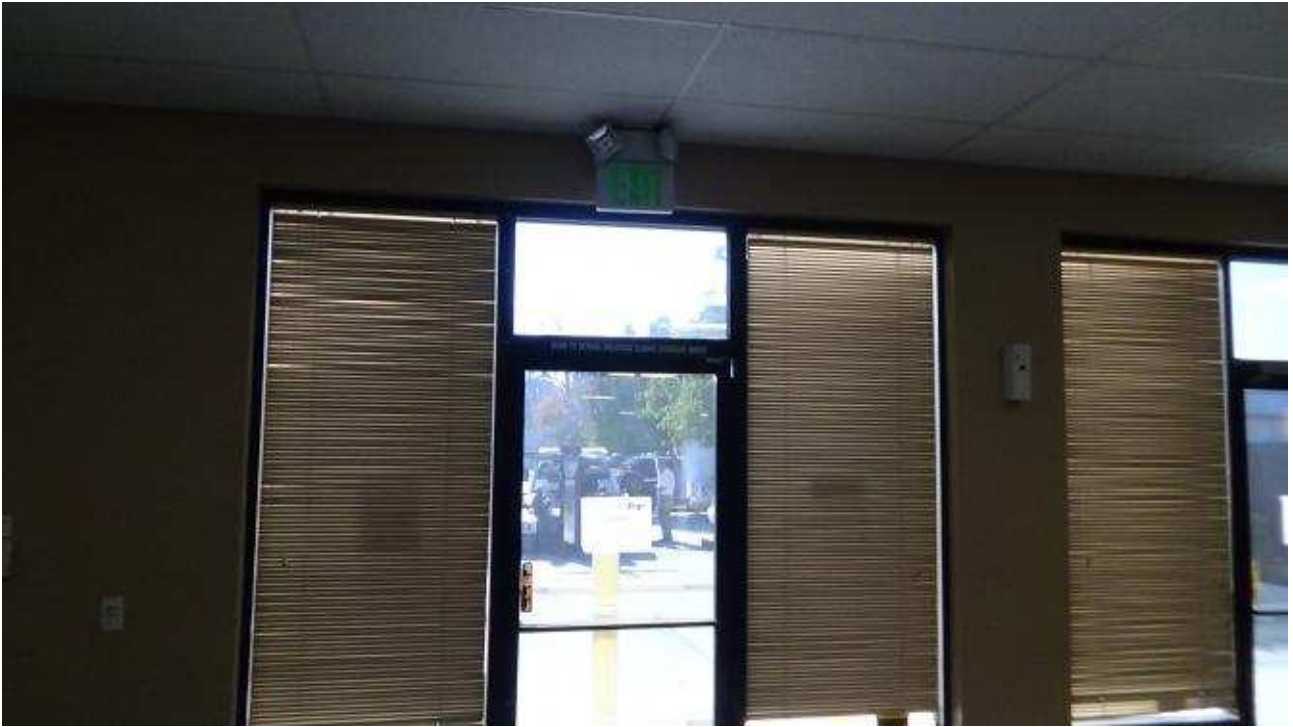
Finding #22 Additional Finding Photos

A tactile EXIT sign is missing at each entrance door.

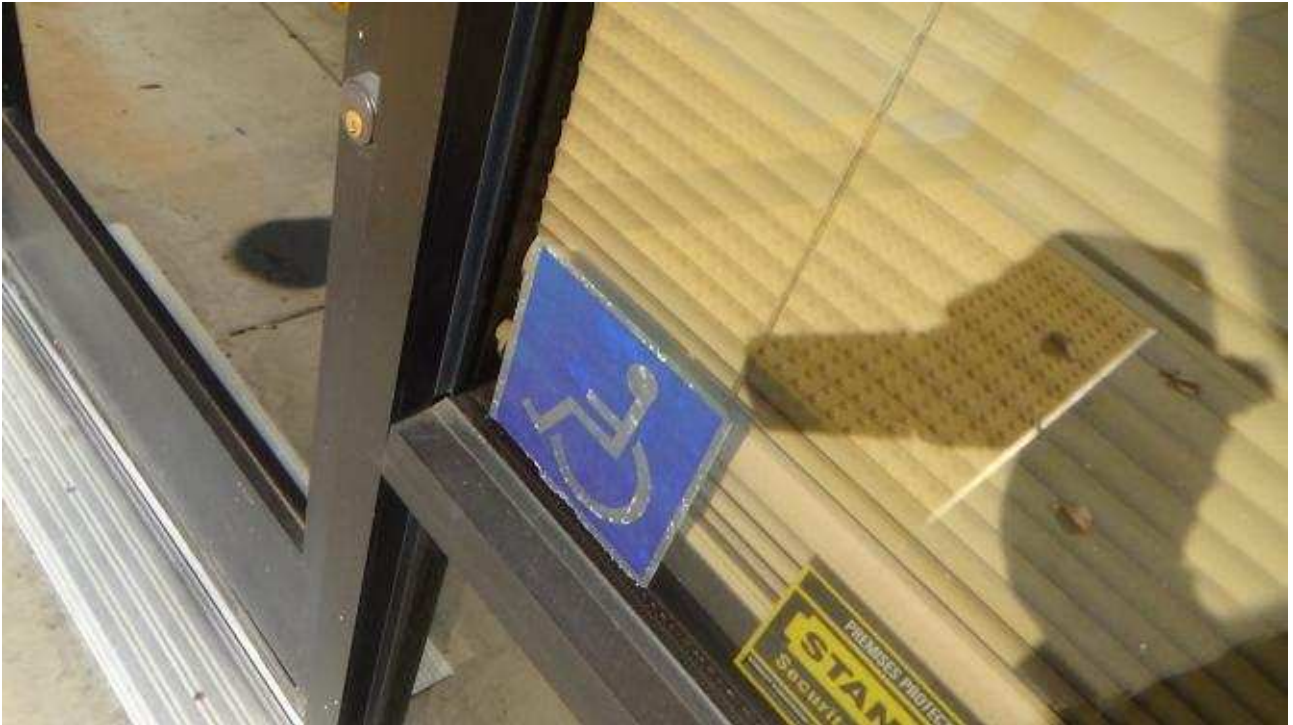
Finding #23 Additional Finding Photos

The ISA symbol at each entrance is faded/worn and in need of replacement and or repair.

Replace ISA stickers with a new ones.

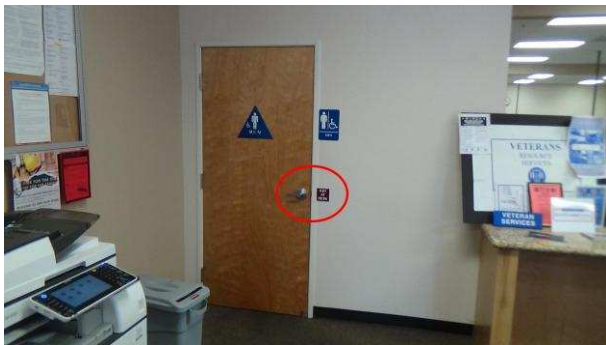
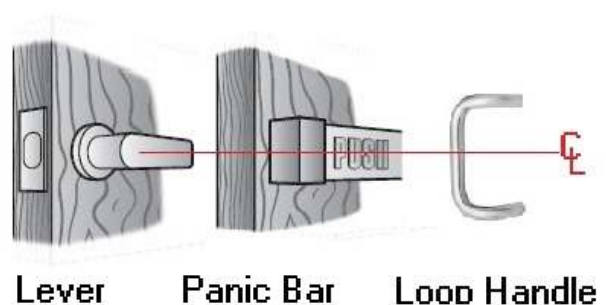
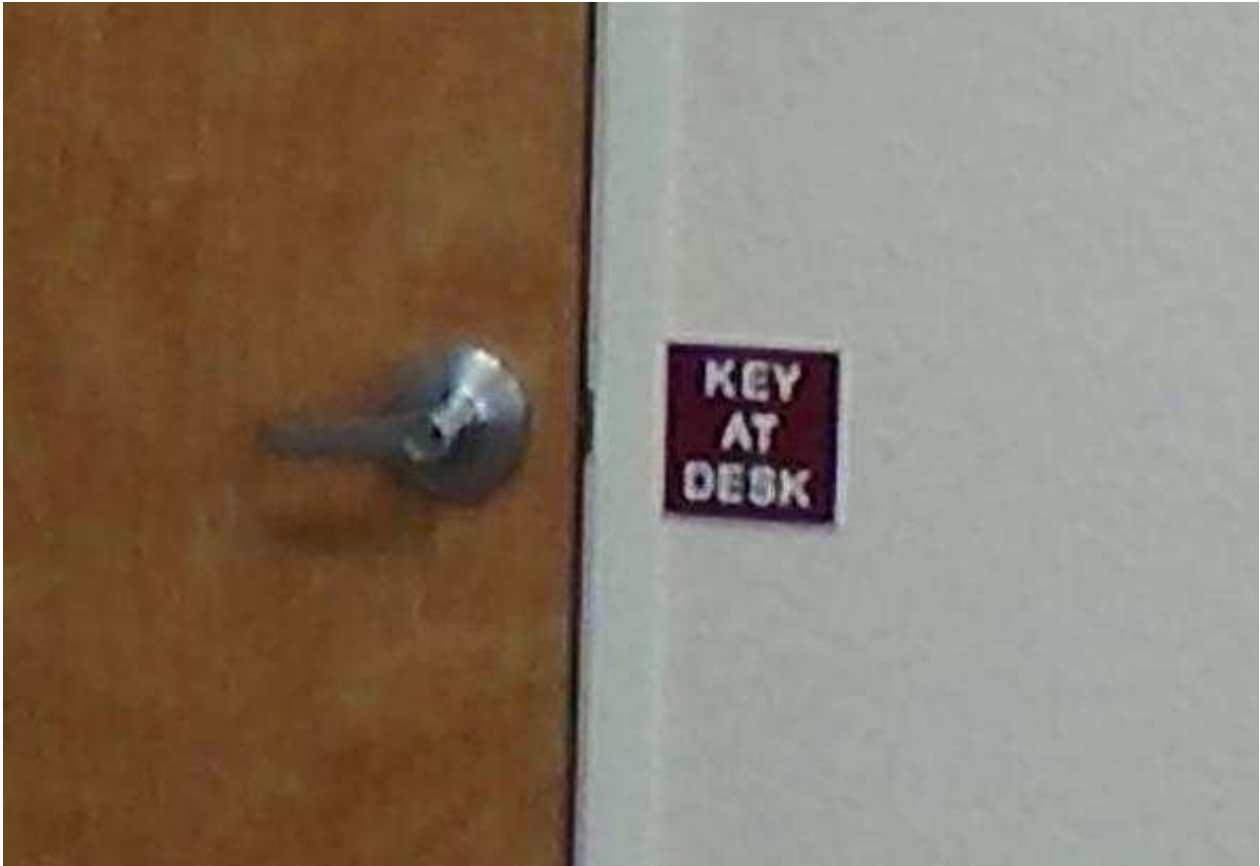
Finding: 30

Operating hardware must be centered between 34" and 44" above the floor or ground

Recommend installing a staff activated deactivation lock for all customers using the restroom or consider a The Norco™ Key Turner III. More info here: https://www.ncmedical.com/item_180.html

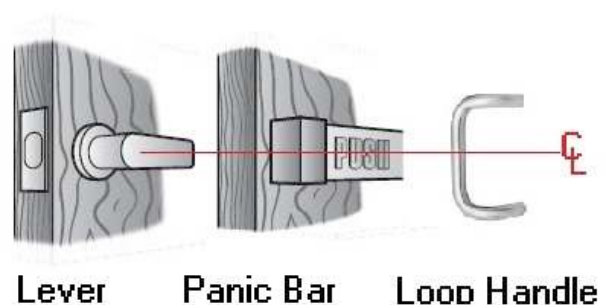
Finding #44 Additional Finding Photos

Operating hardware must be centered between 34" and 44" above the floor or ground

Recommend installing a staff activated deactivation lock for all customers using the restroom or consider a The Norco™ Key Turner III. More info here: https://www.ncmedical.com/item_180.html

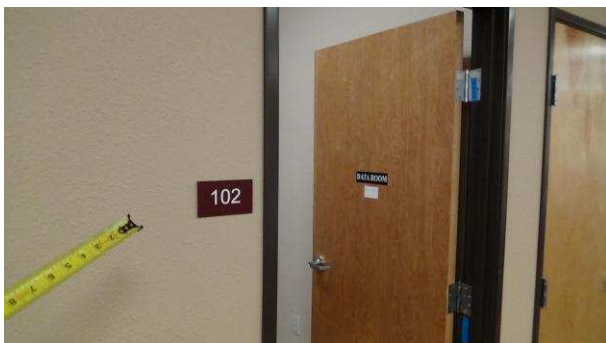
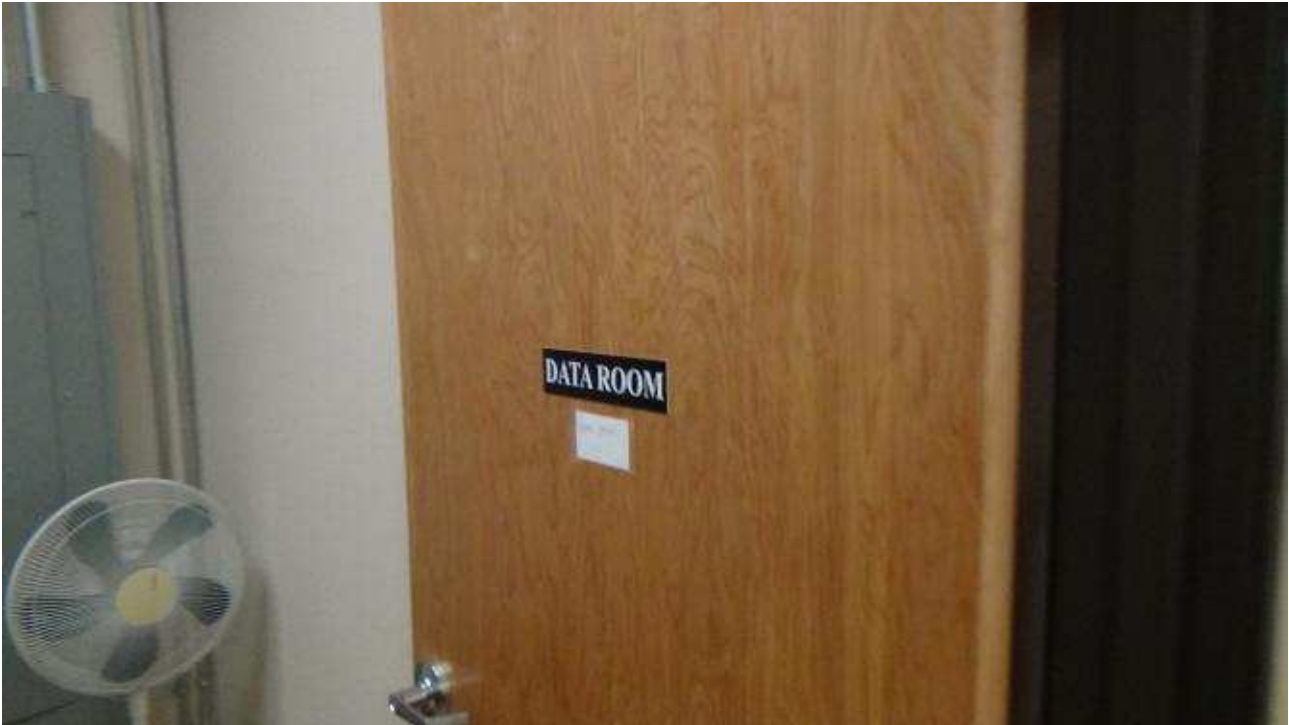
Finding: 52

Compliant room identification signs are missing on the strike side of the door.

Missing Tactile "Data Room: wall sign

Add compliant tactile and braille wall sign for "Data Room" as specified or remove "Data Room" sign from the door.

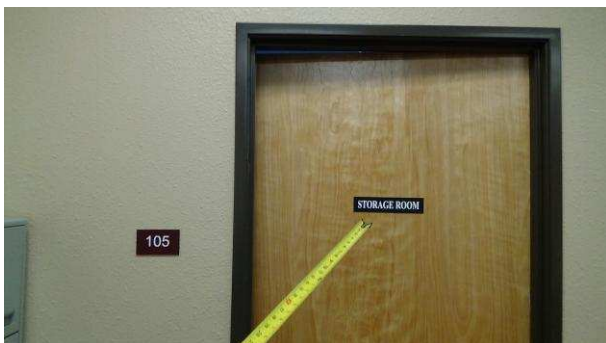
Finding: 54

Compliant room identification signs are missing on the strike side of the door.

Missing Tactile
"Storage Room: wall
sign

Add compliant tactile and braille wall sign for "Storage Room" as specified or remove "Storage Room" sign from the door.

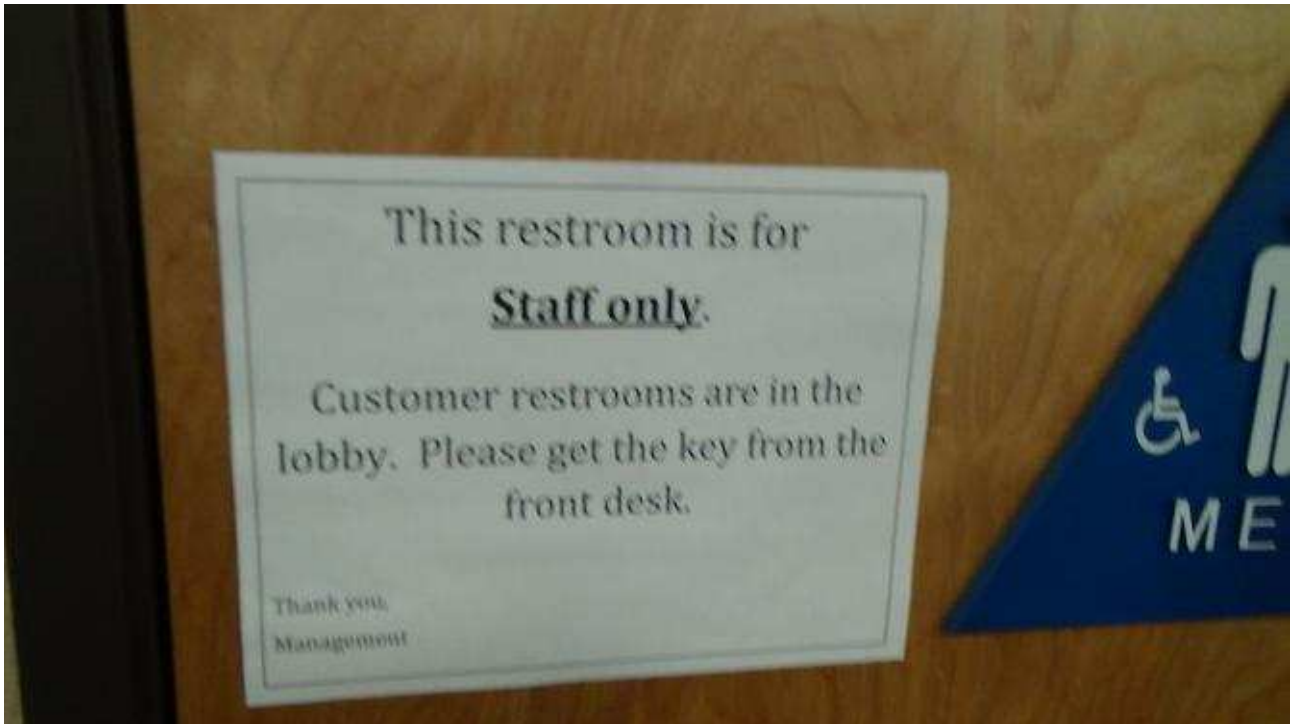
Finding: 55

Compliant room identification signs are missing on the strike side of the door.

Missing Tactile "Staff
Only: wall sign

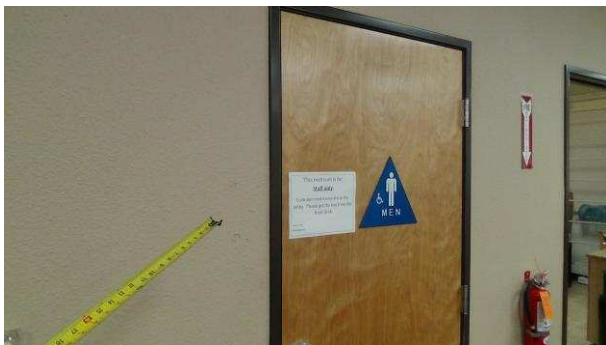
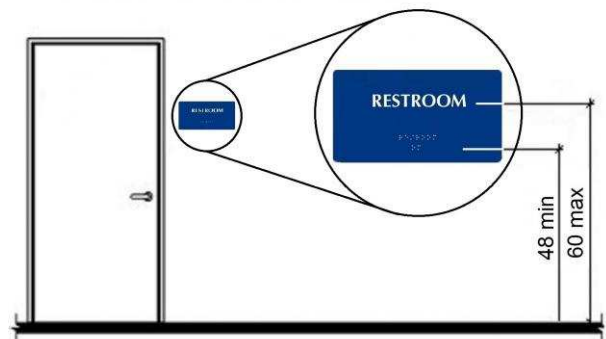
Finding: 56

A compliant room identification sign is missing on the strike side of the door.

Install compliant tactile wall sign as specified.

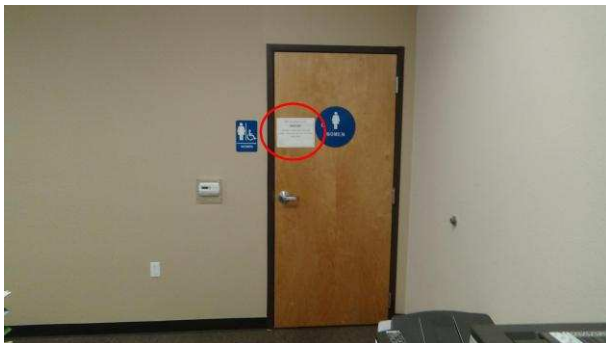
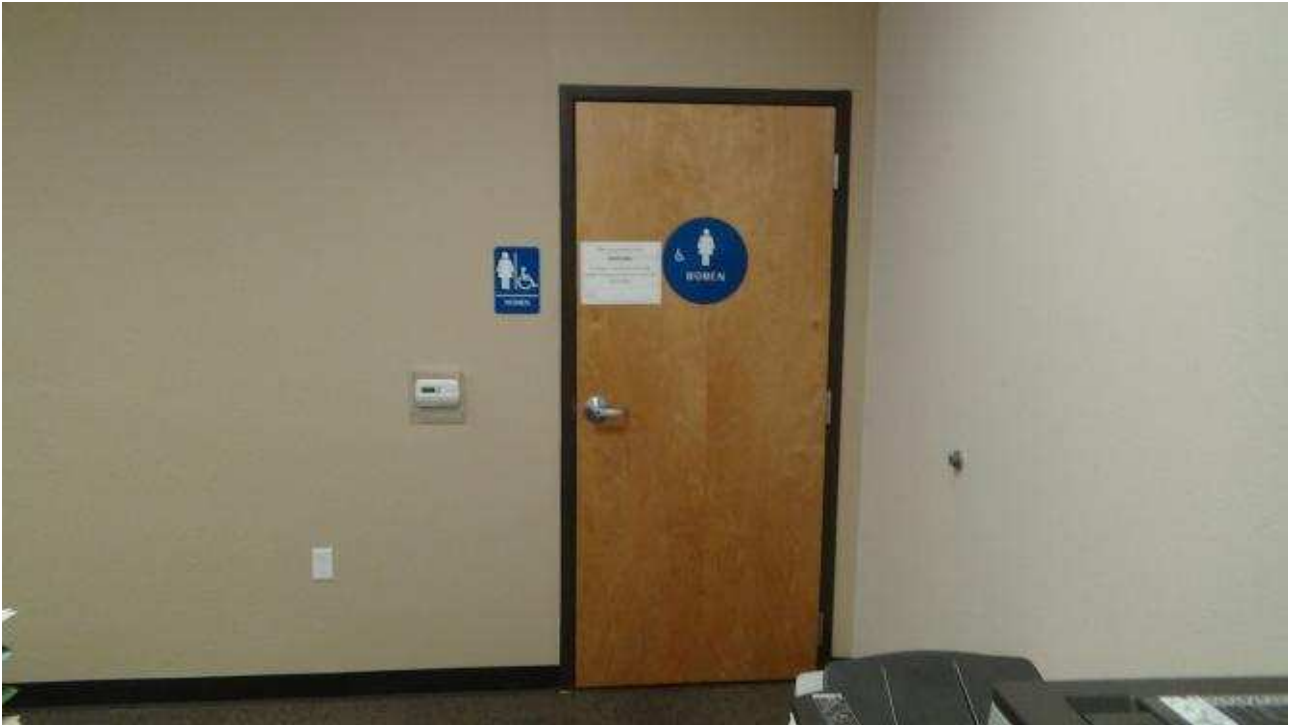
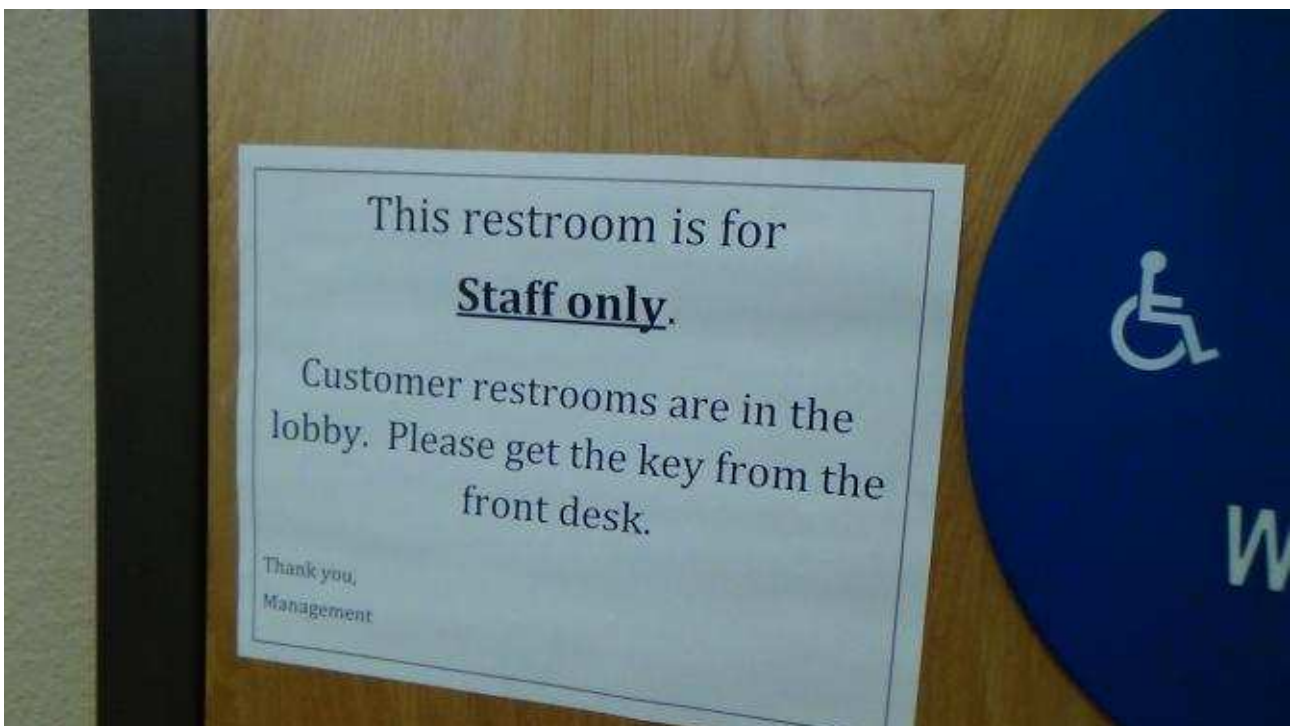
Finding: 63

Compliant room identification signs are missing on the strike side of the door.

Missing Tactile "Staff
Only: wall sign

Add compliant tactile and braille wall sign for "Staff Only" as specified or remove "Staff Only" paper sign from the door.
